September 30, 2012

## **Colrain Center: Main Road, Jacksonville Road and Greenfield Road**

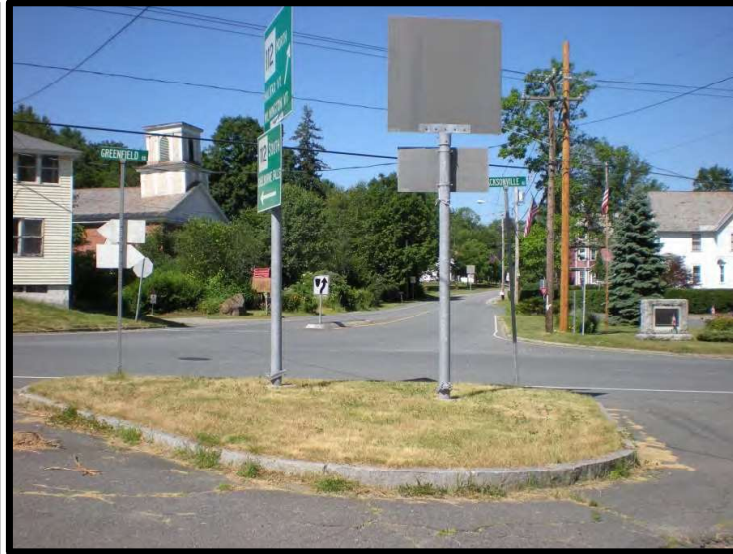
Looking to the west at Main Road from the intersection of Main Road, Jacksonville Road and Greenfield Road in the center of Colrain.

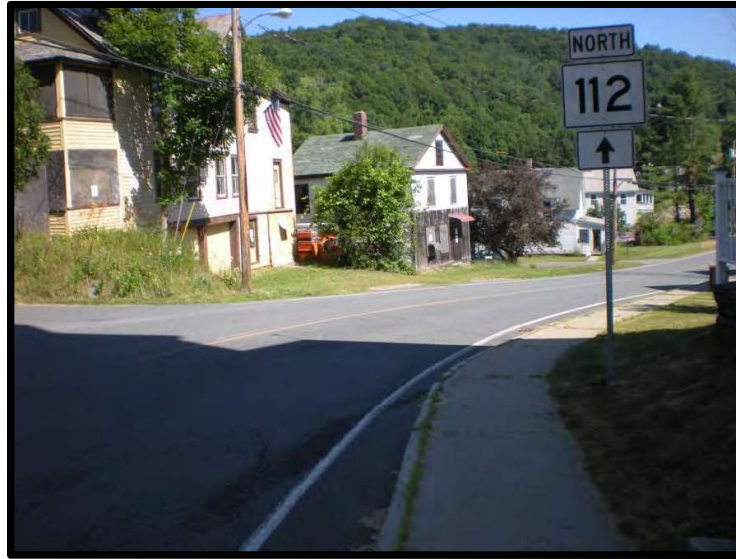
A view to the north on Jacksonville Road (Route 112) from the center of Colrain.

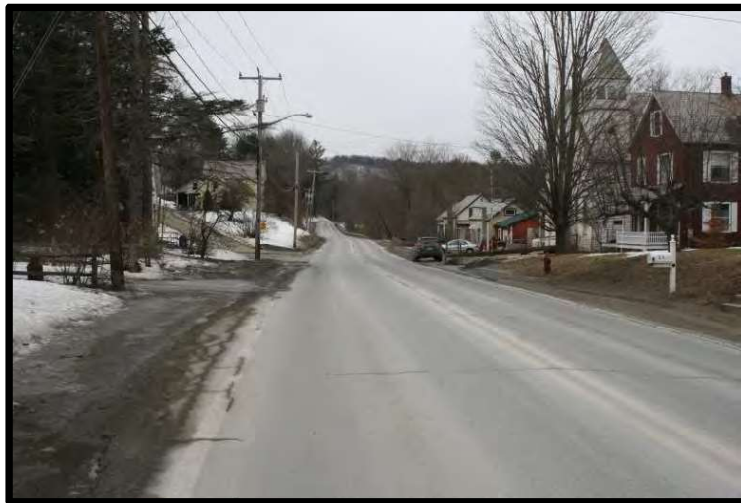
This view of Main Road near the Colrain Public Library shows the lack of sidewalk on this primary route in downtown.

- Construct sidewalks on the road in the center of town where there are none, or reconstruct sidewalks that are in poor condition. There are currently extremely limited sidewalks (two very small sections) throughout the project area. There is a need for sidewalks throughout the project area. Sidewalks and other pedestrian oriented streetscape features would be aesthetically in keeping with the atmosphere and character of the village center. The area that is being examined is within the Colrain Center Historic District, a National Historic District. It is not anticipated that sidewalk improvements would adversely impact the historic district, but it is important to consider that a Section 106 review would be required.

- Construct a sidewalk on the south side of Main Road and on the school side of Jacksonville Road.
- Consider a possible solution to the ADA crossing/grade issue by closing off the slip lane and using that space for the ADA sidewalk through the area that is currently part of the median and the slip lane. The monument that is currently in the median would be relocated to an agreed upon location to the side of the road in the center of town. Further design work would consider the relocation of the monument, addition of a bench and the creation of a more accessible park area. Close off the slip lane to traffic, but create a driveway and space for the residences located to the north of the slip lane road to park. There are also utility poles that would need to be relocated.

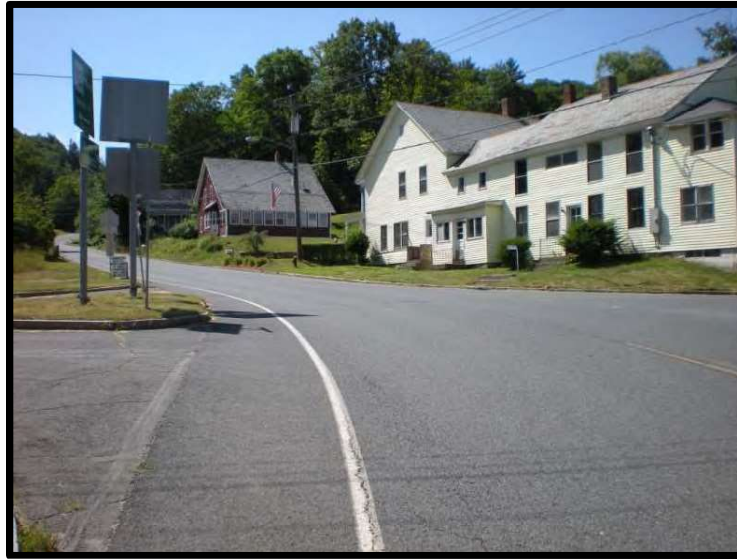
There is a notably absent crosswalk across Jacksonville Road/Greenfield Road to Main Road. Accommodating Americans with Disabilities Act (ADA) requirements for a crosswalk at this location poses a particular challenge because of the steep grade of Greenfield Road. Locating a crosswalk is also a challenge because of the curve of Jacksonville Road (Route 112) as it heads north and the resulting very short sight distance. Overall, the sight distance is very poor for pedestrians crossing from the east side of the road to the west at the center.

A view of Greenfield Road at the intersection with Jacksonville and Main Roads shows the steep grade upon which vehicles traveling north enter the center of town.

- Install advance warning signals for vehicles traveling north on Greenfield Road (Route 112) to alert the vehicles that they are entering the village center and slow the traffic down.

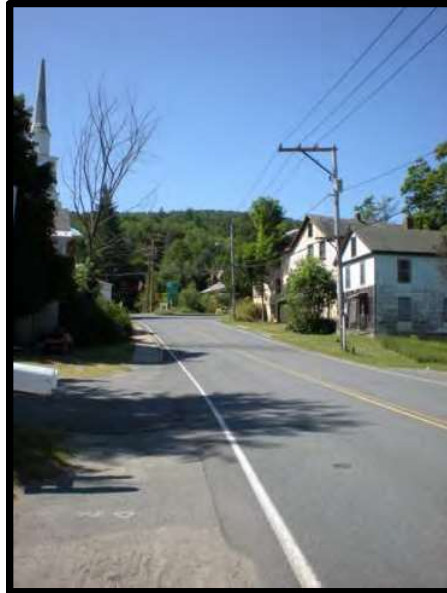
A view of Jacksonville Road looking towards the intersection at the center of Colrain (encroaching vegetation is visible on the left).

- Trim the vegetation along Greenfield and Jacksonville Roads to improve the sight distances. In particular, the site line on Jacksonville Road from the east side looking south towards the center intersection is obscured by vegetation that is on private property and encroaching into the right of way. The encroaching vegetation is obscuring the view of vehicles traveling north on Greenfield and Jacksonville Roads.

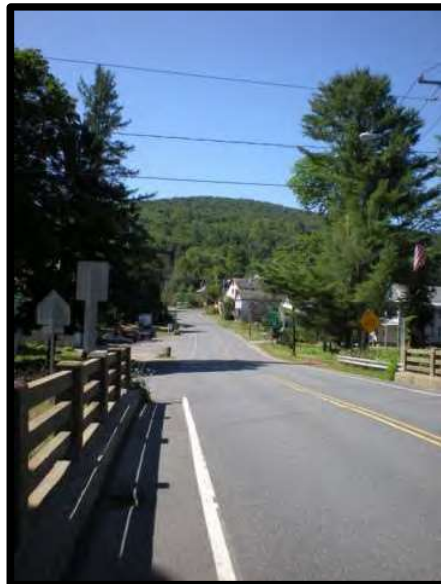
The bridge (with no sidewalks) on Jacksonville Road to the south of the Colrain Central School.

- Construct a sidewalk on one side or both sides of the bridge on Jacksonville Road (Route 112) just south of the Colrain Central School. There is current no sidewalk on either side of the bridge. The bridge is classified as “structurally deficient” by MassDOT, and is scheduled to be reconstructed in the future. However, the reconstruction project will not be completed for 5 or 6 years. Maintenance work is scheduled to be completed in 2 or 3 years. When work is completed to reconstruct this bridge it is recommended that a sidewalk be added to one side, or if possible both sides, of the bridge. At the site visit FRCOG staff and MassDOT District 1 staff discussed which side of the bridge would be better for the sidewalk in the event that it is not possible to add a sidewalk to both sides of the bridge. It was determined that the side that the school is on (west side) would be the preferred location so that the children walking to school can easily access the school property. The school is right next to the bridge on the northwest side.

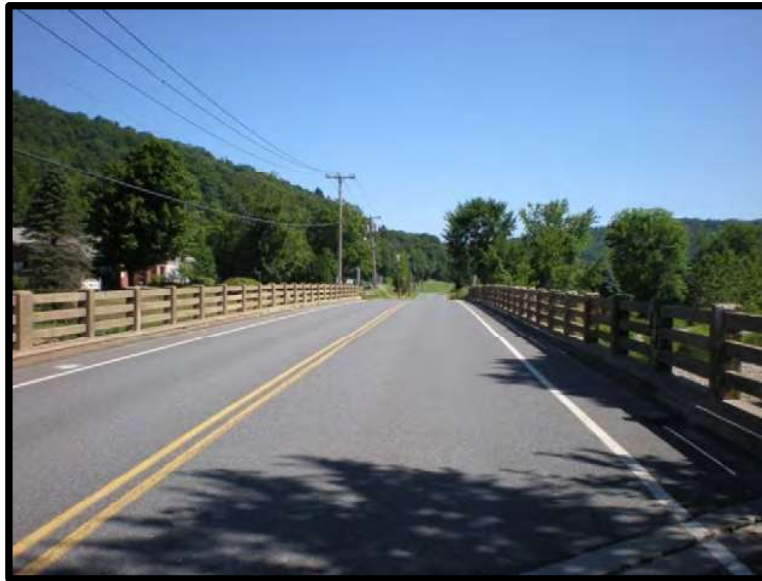
A view to the north of the bridge on Jacksonville Road (Route 112) with the Colrain Central School to the left of the bridge.

- Consider bicycle use during the design stage for any and all pedestrian improvements. In particular, bicycle accommodation should also be considered as part of the design work to accommodate pedestrian use on the bridge on Jacksonville Road.

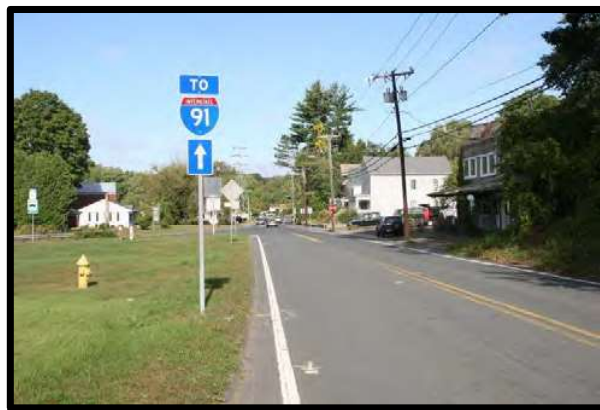
A view of Route 5/10 (Deerfield Street) from Cheapside Street.

The intersection of Deerfield and Cheapside Streets in Greenfield is a triangular intersection with the southbound incoming and outgoing traffic coming to a t-intersection, and the northbound incoming and outgoing traffic using a slip lane. This intersection was the focus of a road safety audit that was completed by Stantec Consulting Services for MassDOT in November 2011. The recommendations of the road safety audit included the study of the reconfiguration /consolidation of the Cheapside Street intersection with Route 5/10 in order to eliminate the slip lane and create a T-intersection with a left turn lane on Route 5/10. This would eliminate the split and discontinue the “long” side of the triangle (Cheapside Street) as a through way.

The draft road safety audit report commented that a follow-up design study also consider a roundabout as a possible reconfiguration option for this intersection in order to reduce the overall number of conflicting movements. At this time, MassDOT is moving forward with a study to redesign this intersection. It is included in the Fiscal Year 2015 element of the Franklin Regional Transportation Improvement Program (TIP).
